## 4.13 AESTHETICS

This section summarizes the visual analysis technical study prepared by Kawasaki Theilacker Ueno + Associates (KTU+A) in December 1998 (Appendix P). Major tasks conducted for the KTU+A study include the identification of the visual character; description of visually prominent project elements; determination of project visibility; quantification and qualification of viewer groups; preparation of special landform models; creation of visual simulations; and the determination of visual impacts. The study also documents the process and the effects of various mitigation measures and discusses alternative project design where appropriate.

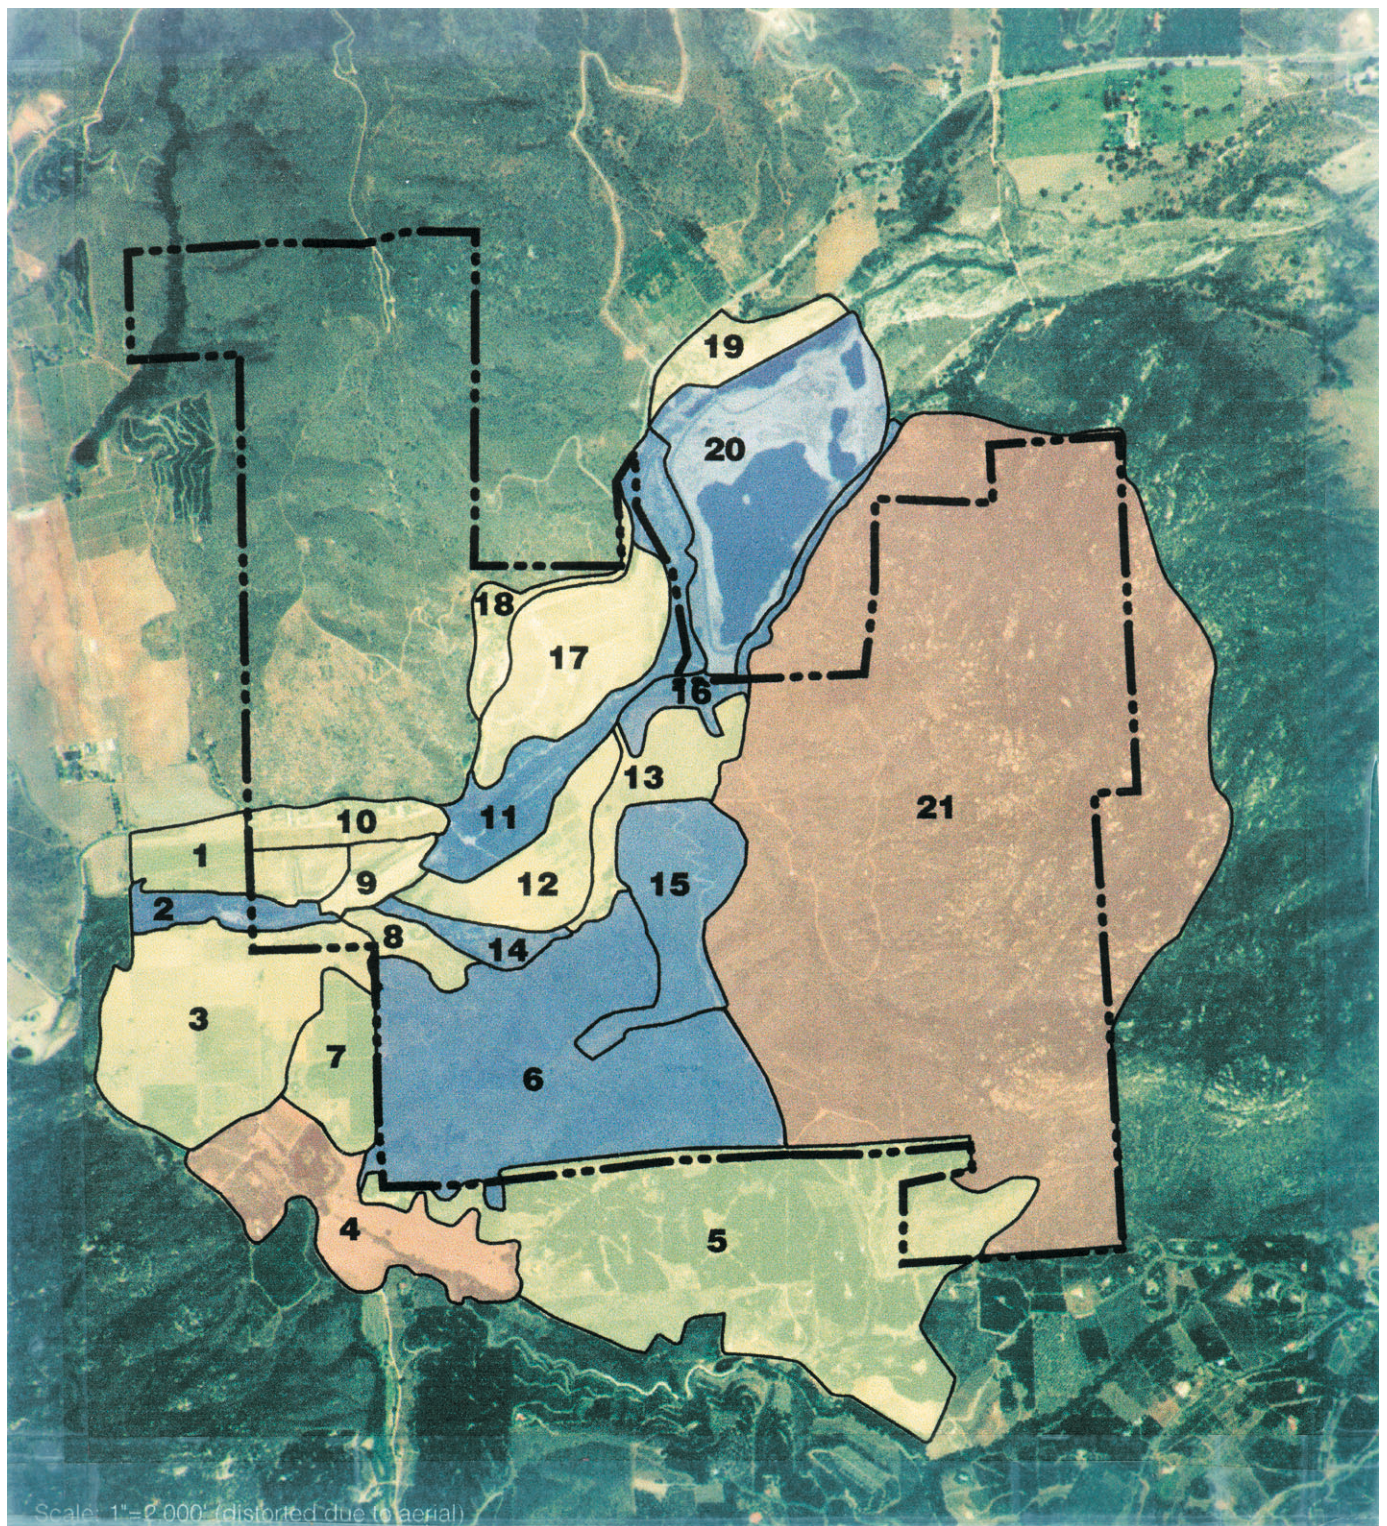
Exhibit 4.13-2  
 Visual Resources  
 Classification

Resource classifications result from overlaying the visual quality, sensitivity, and distance zones. Exhibit 4.13-2 delineates the three composite resource classifications for the site using the BLM Visual Resource Management definitions of management classification, which describe the different degrees of modification allowed to the basic elements of the landscape. The majority of Gregory Mountain is placed in resource Class 2.

**Class IV** (Slight Sensitivity, Visibility, & Quality)

**Class III** (Moderate Sensitivity, Visibility, & Quality)

**Class II** (High Sensitivity, Visibility, & Quality)

Major visual elements introduced into this area would require extensive screening and on-site replacement/rehabilitation. Some smaller areas of the project site (and directly adjacent areas) have been grouped in the Class 3 category. This area can be disturbed but must be visually subordinate to the other elements of the landscape. The remaining areas are grouped into Class 4, where disturbances can be visible and even dominant, but should still retain the line, texture, form, and color of the adjacent landscape units.

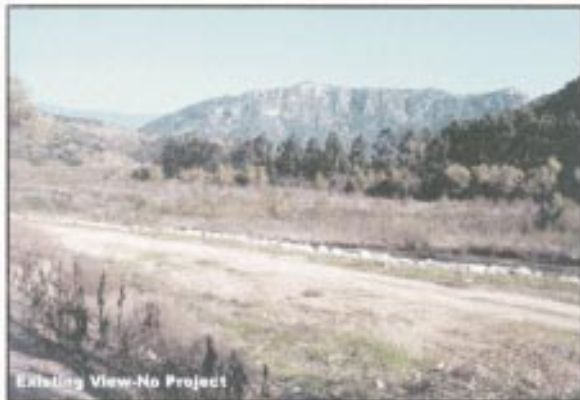
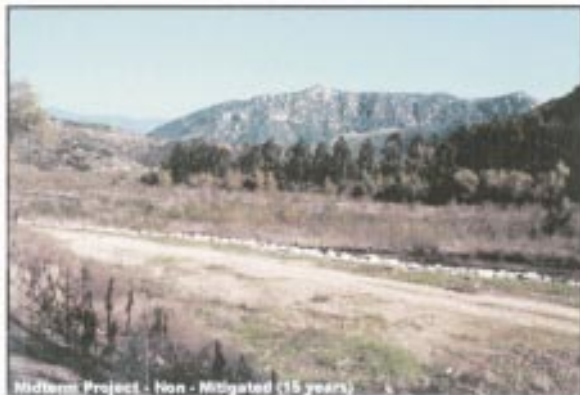
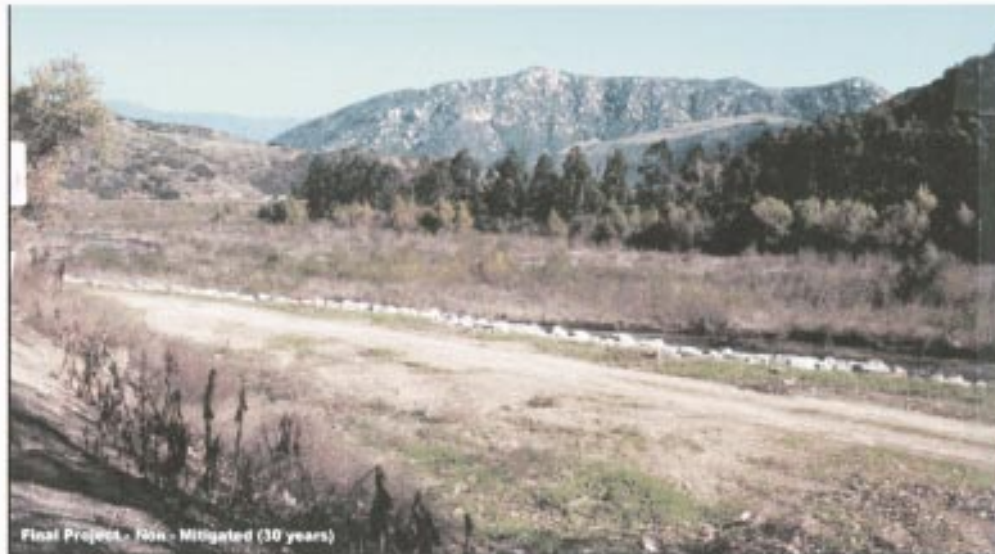
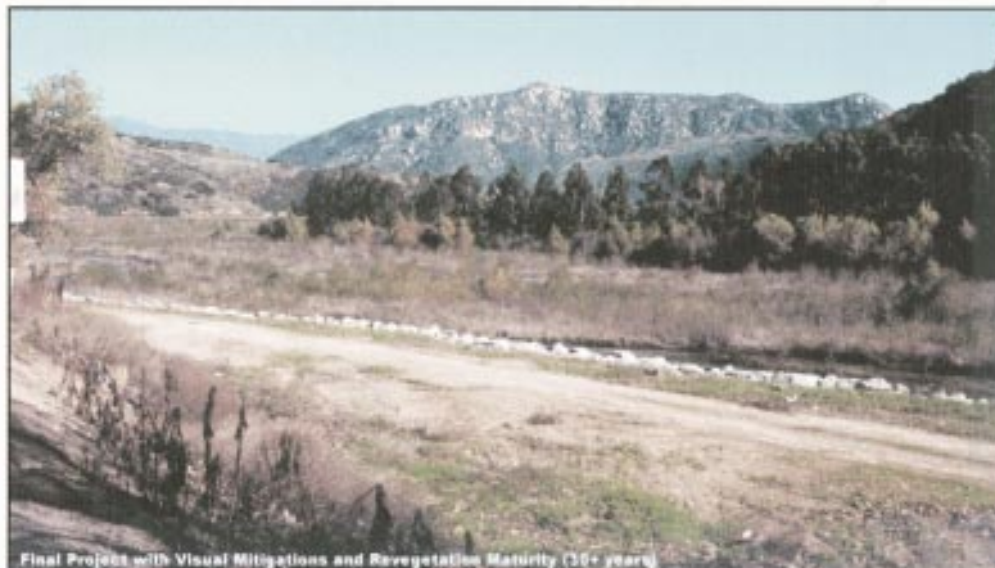
# Central San Luis Rey Canyon

Existing View-No Project

Midterm Project - Non - Mitigated (15 years)

Final Project - Non - Mitigated (30 years)

Final Project with Visual Mitigations and Revegetation Maturity (30+ years)

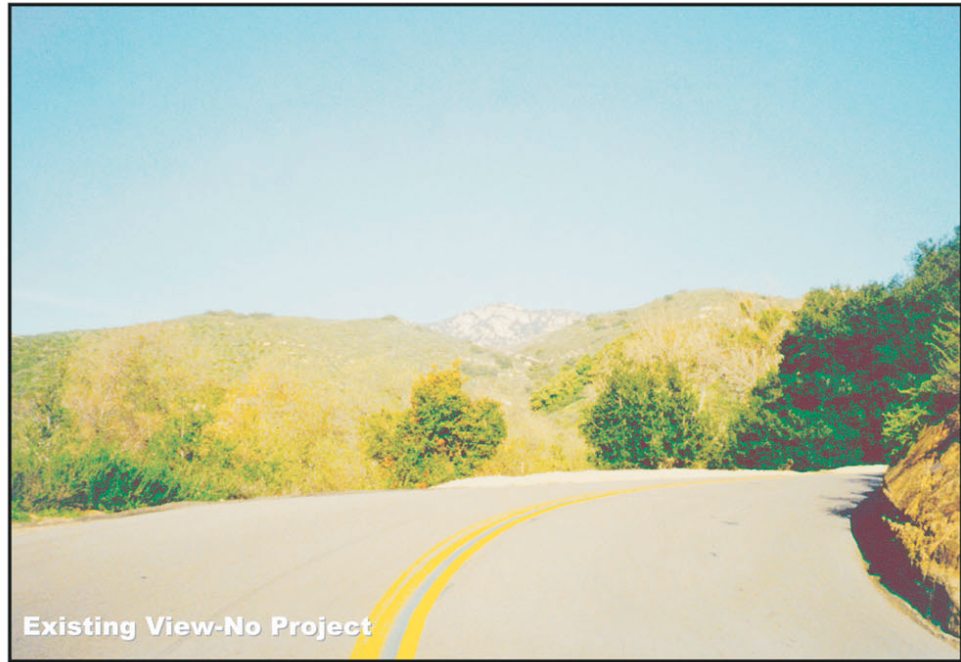
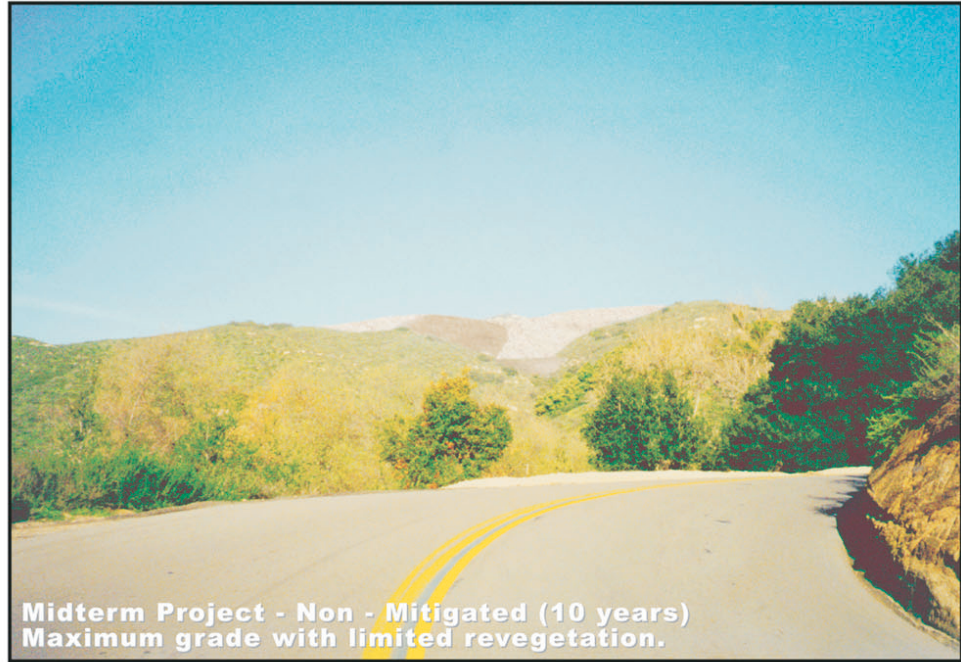
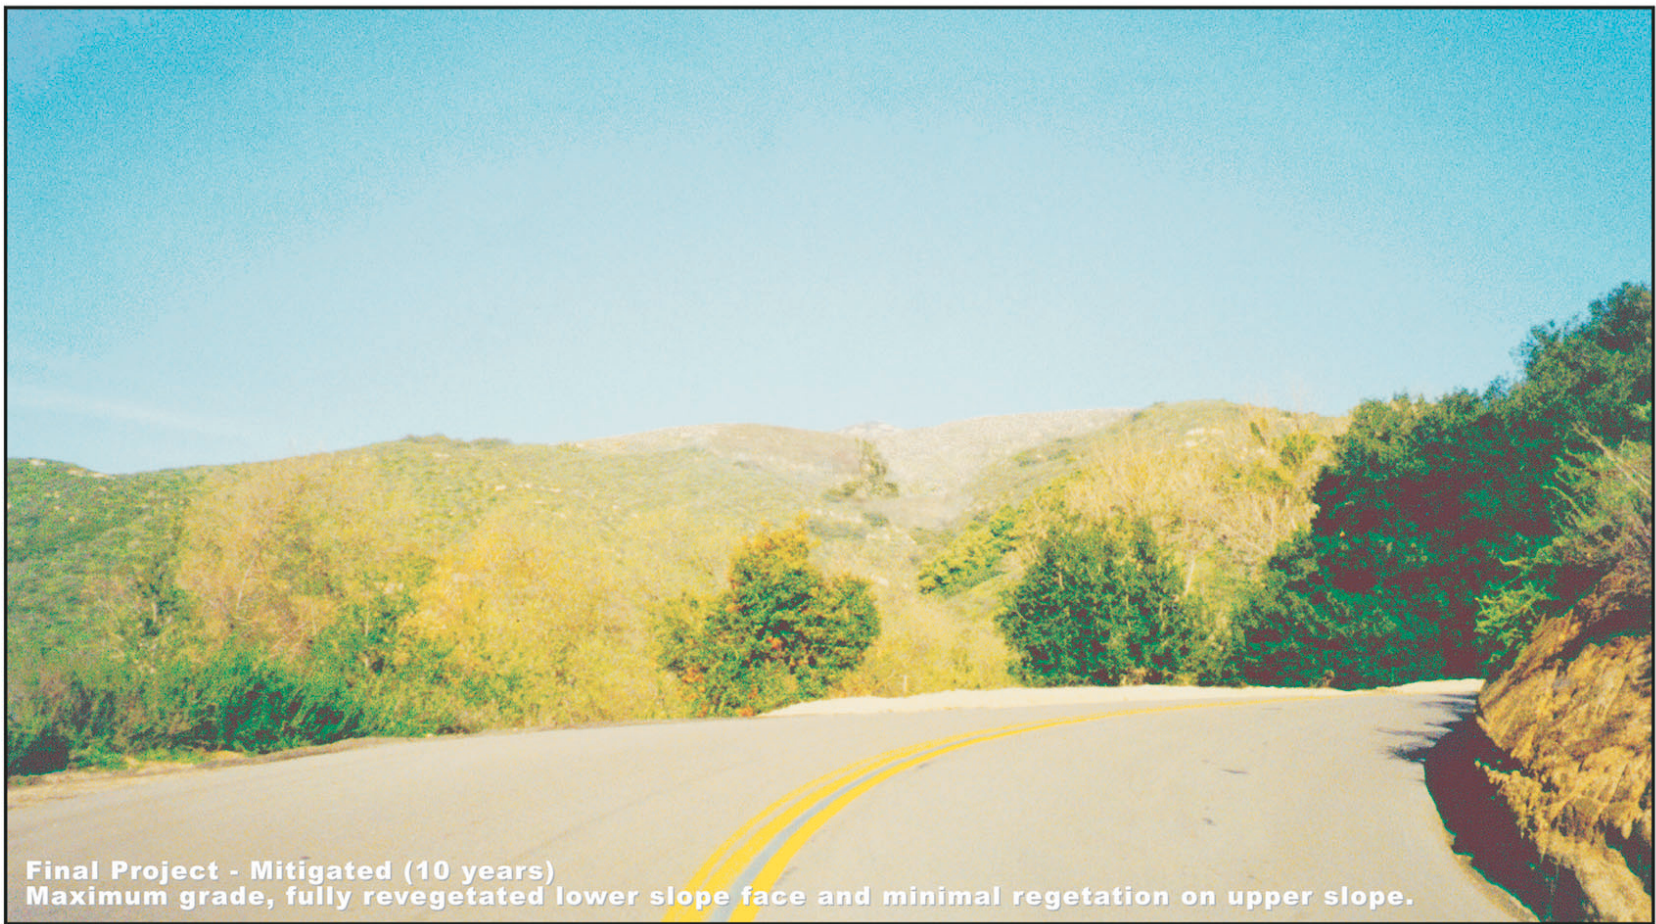
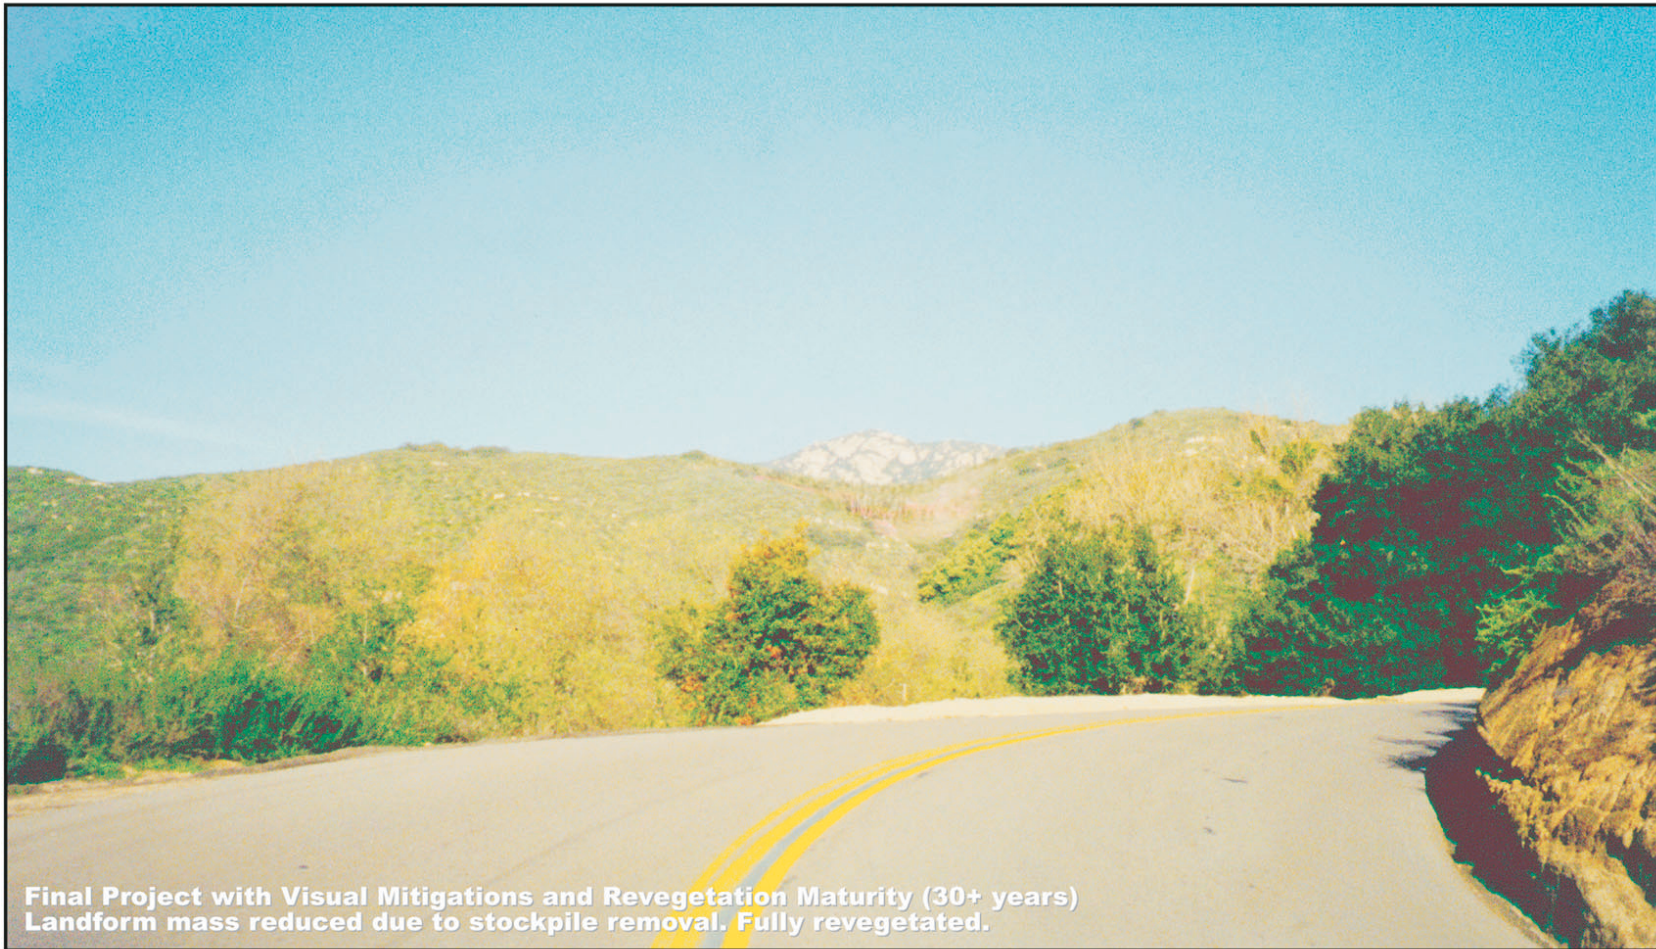
Lower  
Couser  
Canyon

Existing View-No Project

Midterm Project - Non - Mitigated (10 years)  
Maximum grade with limited revegetation.

Final Project - Mitigated (10 years)  
Maximum grade, fully revegetated lower slope face and minimal regetation on upper slope.

Final Project with Visual Mitigations and Revegetation Maturity (30+ years)  
Landform mass reduced due to stockpile removal. Fully revegetated.

Borrow/Stockpile Area B would be located in a canyon that has a natural appearance. This canyon area is highly visible to highway drivers as well as residents in Rice and Couser Canyons, especially along Couser Canyon Road. The contrast with the existing visual setting would be high. The visual quality of this landscape unit is moderate. The sensitivity to change is high and the ability of the site to absorb change is considered to be low. The visual resource class of Borrow/Stockpile B is Class 3. Based on these conditions, the Borrow/Stockpile Area B would have a significant impact on visual quality.

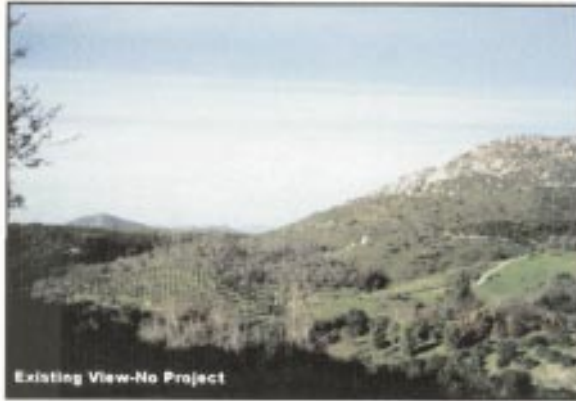
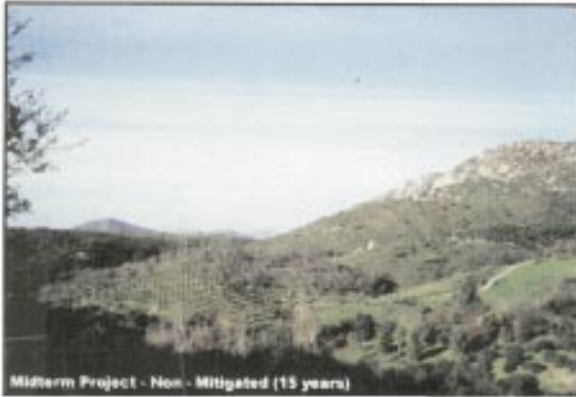
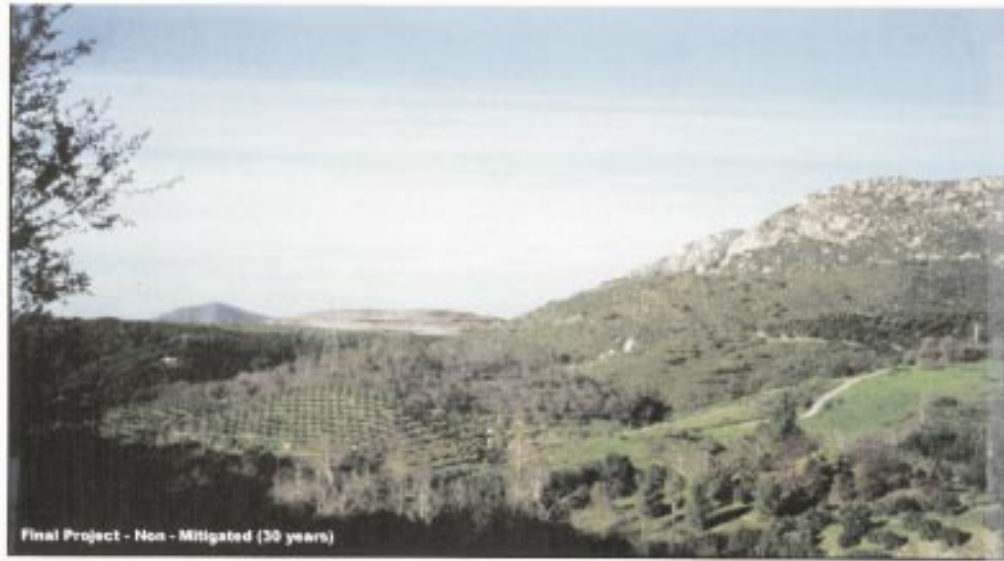
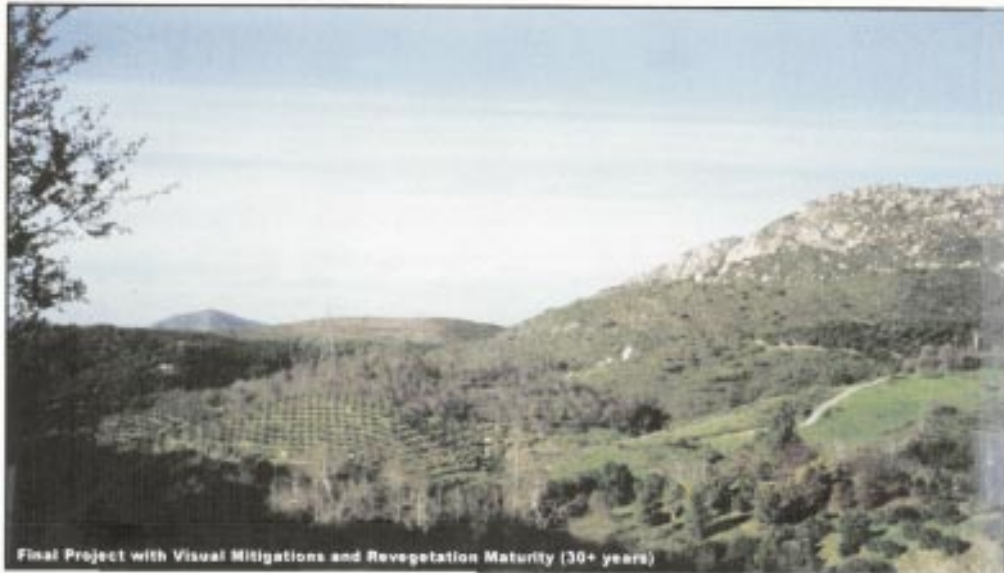
# Upper Couser Canyon

Existing View-No Project

Midterm Project - Non - Mitigated (15 years)

Final Project - Non - Mitigated (30 years)

Final Project with Visual Mitigations and Revegetation Maturity (30+ years)
